# St Brandon's Parish Church, Brancepeth, Durham Diocese, England

## Archaeological Discoveries After the Church Fire

Interim Report II February 1999

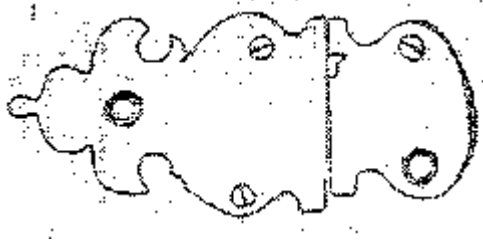
Hinge from 17th Century furnishing (EB98.93)

Most of the substantial wrought iron Door Hinges are still intact, even though no trace of the doors themselves can be found. Some of these have simple, but attractive decoration. They are being kept towards the restoration of the church. Similarly, a range of seventeenth century "fleur de lis" decorated hinges are the only surviving clues to the existence of the pulpit and other wooden fittings of the church. These, too, are being preserved.

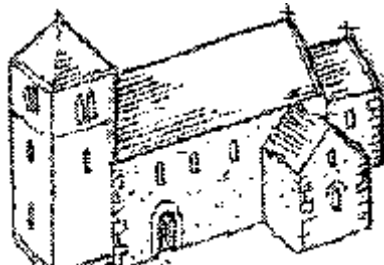
## Mid 13th Century (early English)

By the mid-13th century (early English) the tower has been heightened (c. 1200) and an aisle added to the nave; this drawing shows the chancel as rebuilt around this time as well - this is pure guesswork.

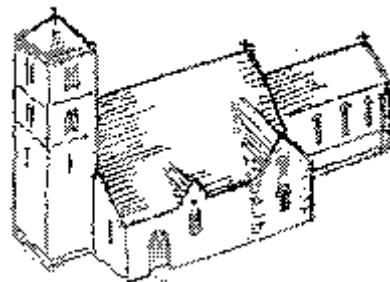
## Early 14th Century (Decorated)

The early 14th century (Decorated); the south transept is rebuilt, perhaps as a burial place for the 'Peacock of the North' (d.1318).

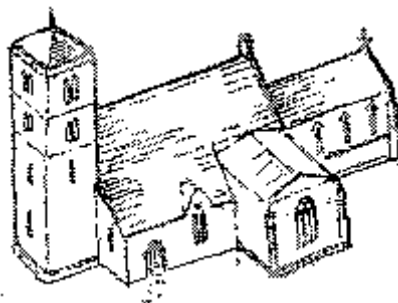
### Later 1300s (Perpendicular style)

The Nevilles further enlarge the church; by the later 1300s (Perpendicular style). The chancel and aisles have been rebuilt, and the tower given a new parapet (very like that of one of the turrets at the Castle)
